Manhole Inspection Summary

Manhole # S35AA_025MH

Location Address: **814 hargrove alley**

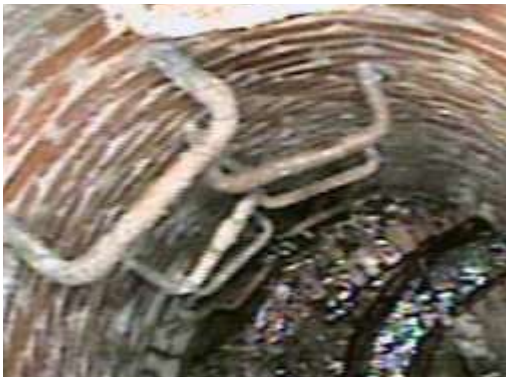
Defect 1

Steps Count: **8** Missing: **0** ☒ Corroded

corroded steps

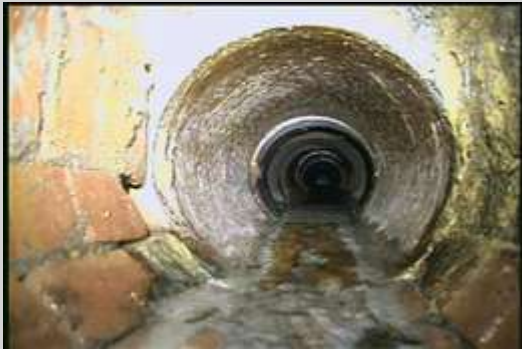
12 O'Clock Outflow

12 in. Circular Gravity Sewer
Pipe Out @ 12 O'Clock

Pipe Material: **Clay** ☐ Pipe Lined

Invert Depth: 14.00 (ft.) Flow Characteristics: **Slow**

Deposits: ☒ None ☐ Mud ☐ Sludge ☐ Debris ☐ Grease

Infiltration: **None** Pipe Seal Cond: **Unknown**

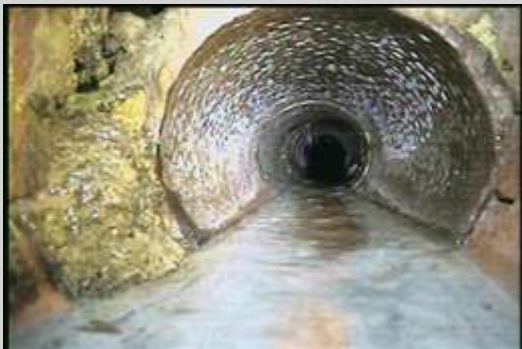
6 O'Clock Inflow

12 in. Circular Gravity Sewer
Pipe In @ 6 O'Clock

Pipe Material: **Clay** ☐ Pipe Lined

Invert Depth: 13.95 (ft.) Flow Characteristics: **Slow**

Deposits: ☒ None ☐ Mud ☐ Sludge ☐ Debris ☐ Grease

Infiltration: **None** Pipe Seal Cond: **Unknown**
